WYLE LABS HUNTSVILLE ALA  
CAPSIZING/SWAMPING ACCIDENT INVESTIGATIONS FOR 1976 SEASON. (U)  
SEP 77 J BOWMAN, B SMITH

CAPSIZING/SWAMPING ACCIDENT INVESTIGATIONS FOR 1976 SEASON

16. Abstract From several hundred boating accidents, 28 were selected for in-depth investigations. These in-depth investigations were performed to augment and supplement the Coast Guard's data base acquired from the nationwide Boating Accident Reports (BARs). Unlike the several thousand BARs received annually, the in-depths contain details of the entire accident scenario and are used to assist in establishing national programs of loading related accident prevention by boat design and education.  This report summarizes the criteria for selection of those accidents to be investigated, the investigation procedures, and the accident data obtained for the 28 in-depth investigations. Each individual accident report is presented as Appendices to the summary report. The accident reports present information concerning the weather, the involved boat and occupants, causal factors, boat capacities and loading/powering information, and occupant actions/reactions prior to, during, and after the actual accident event.

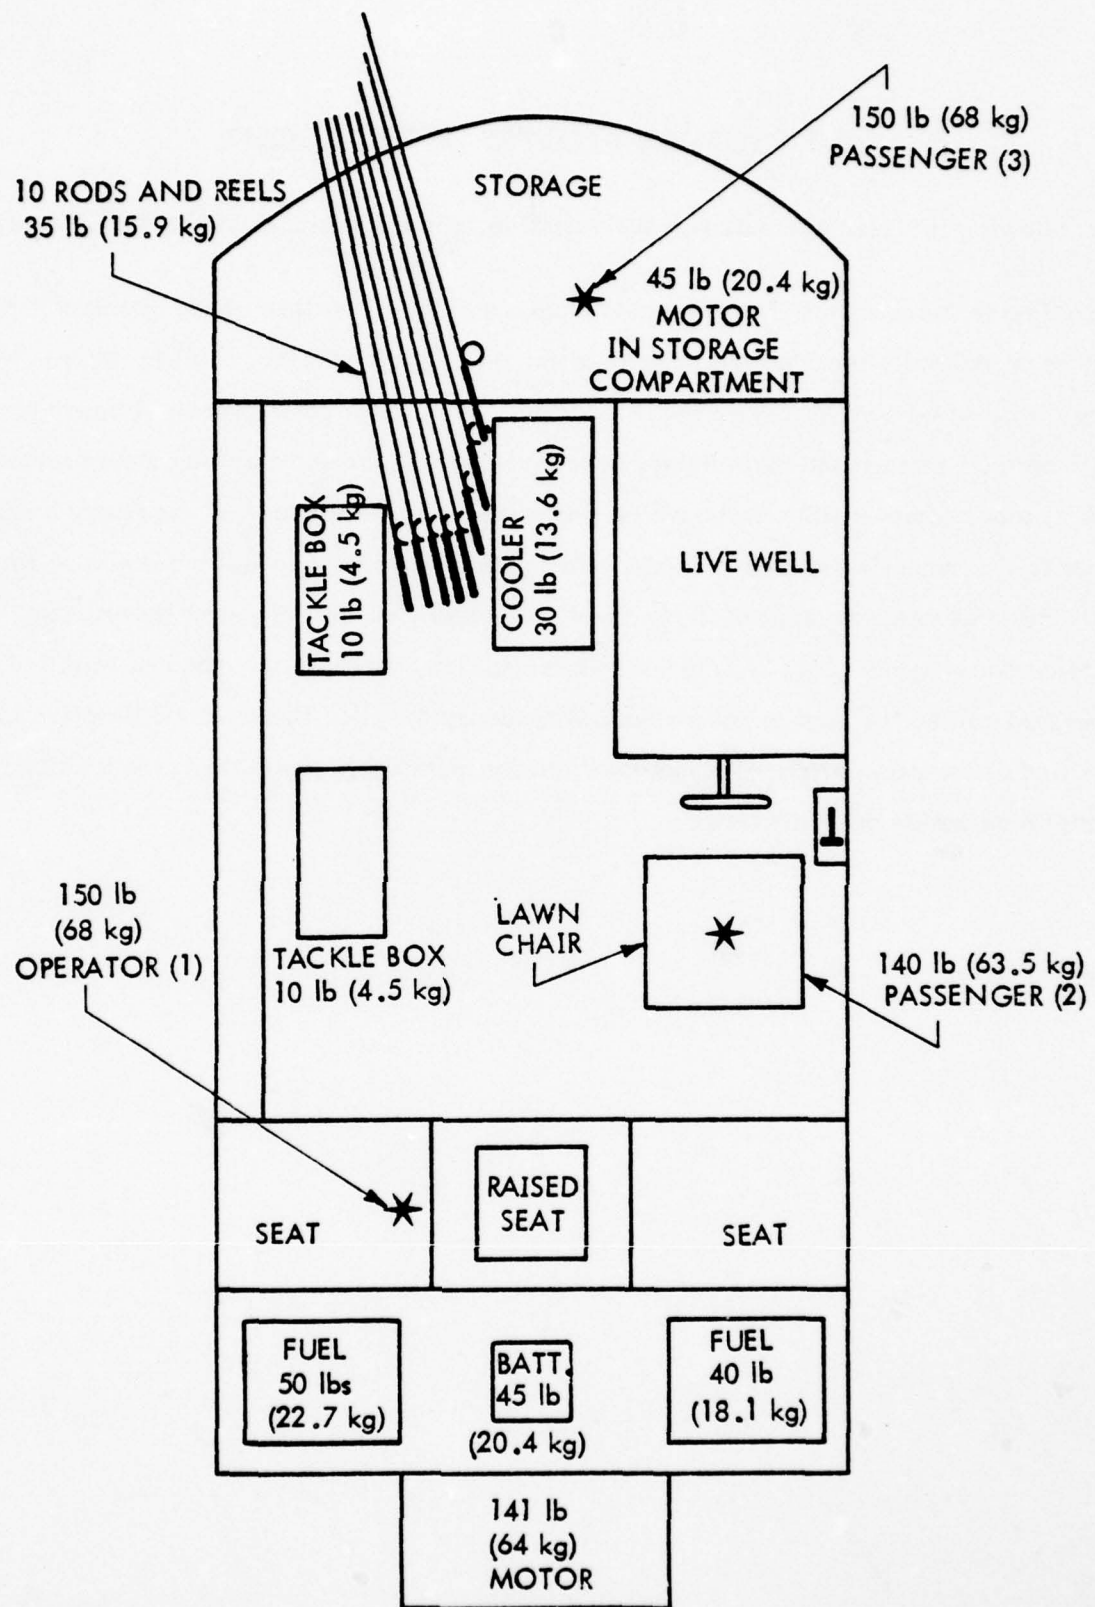
FIGURE 1. LOAD DISTRIBUTION AT TIME OF ACCIDENT

According to the operator, the inner hull plugs were out at the time of the accident. He stated that he purposefully removed the plugs to allow the water in the inner hull to drain to the stern where it could be pumped out by the bilge pump. Water that came over the transom ran into the inner hull through the drain holes, helm seat mounting holes, and the cutout at amidships. When water became visible in the aft section of the boat, the inner hull contained enough water to significantly reduce the transom freeboard. Waves continued to break over the stern until the freeboard was reduced to the point that water flowed freely over the transom, completely swamping the boat. As the boat started to sink, the flotation material installed in the inner hull caused the boat to have a natural tendency to roll. There was no flotation material installed above deck level. With all the flotation material in the bottom, the boat became very stable in an upside down attitude.

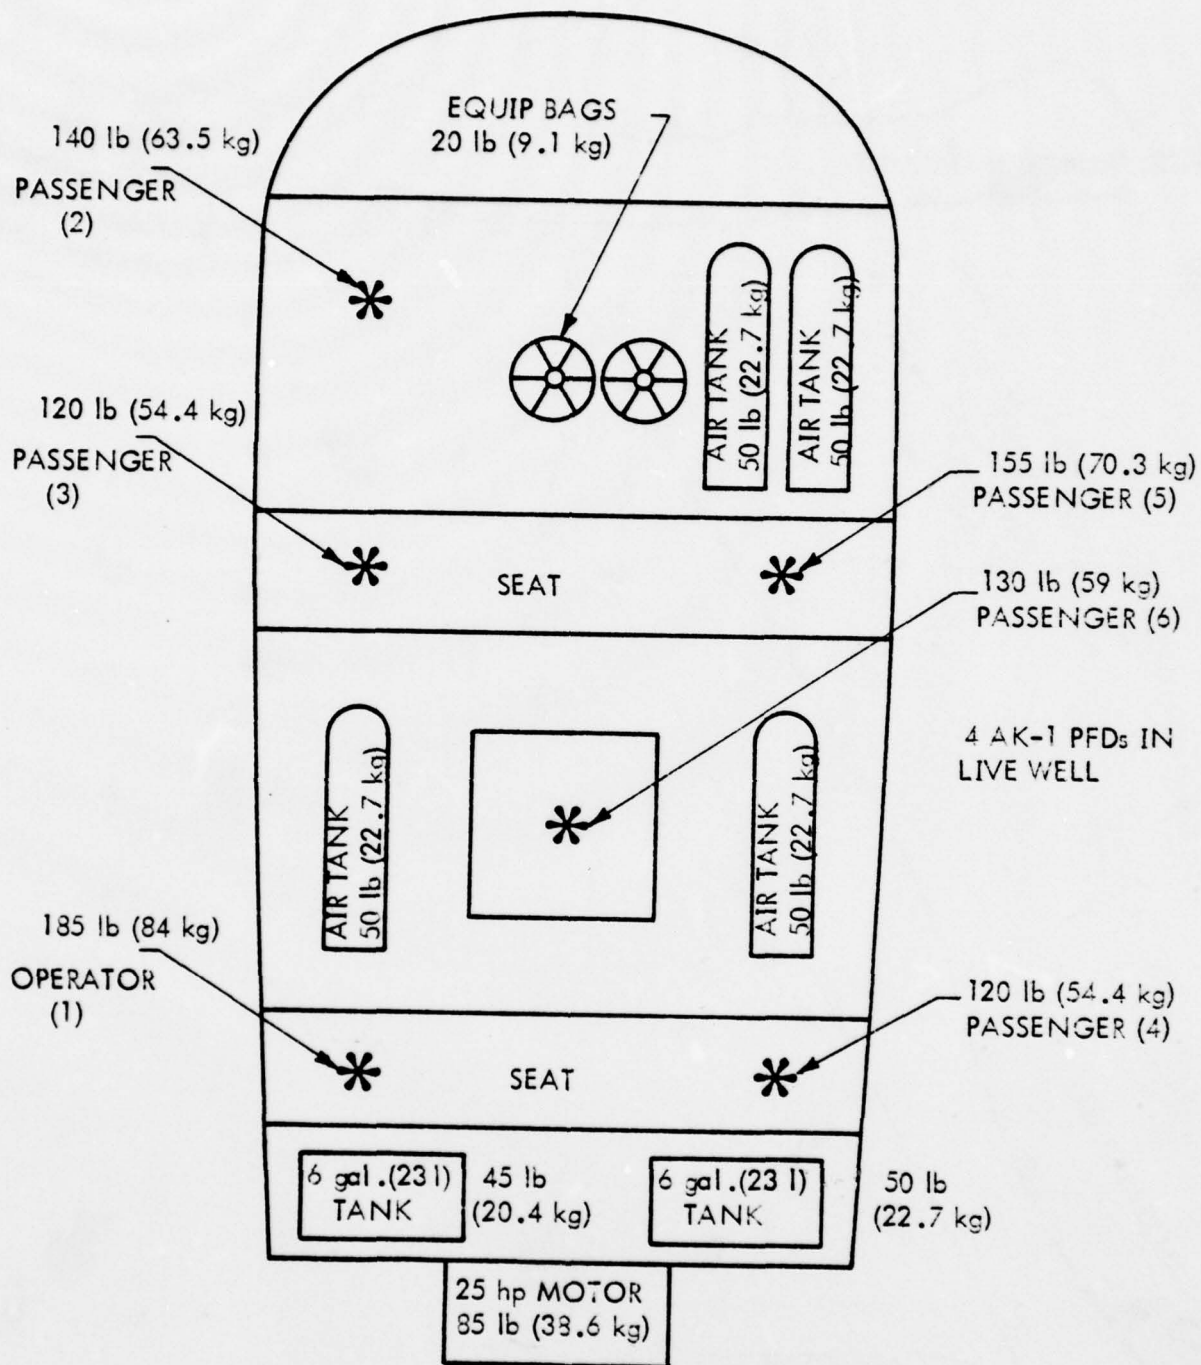
FIGURE 1. LOAD DISTRIBUTION AT TIME OF ACCIDENT

According to the estimated weight in the boat at the time of the accident, the loading exceeded the maximum weight capacity, and there was most likely a significant amount of free water in the inner hull. The load distribution was such that the boat was most likely running essentially in a level attitude at approximately five mph (eight kph). The boat went over the crest of the two to three ft (0.6 - 0.9 m) wave and headed bow first into the trough. As the boat headed down the wave, any water in the inner hull would flow forward, increasing the weight in the bow. When the bow reached the trough, people, gear, and water weight in the bow and forward momentum of the boat caused the bow to slice into the next wave. The bow freeboard was reduced to zero and allowed water to flow freely over the bow, flooding the boat. With the flotation material installed low in the boat and the center of gravity of the weight in the boat at a much higher level, the boat had a natural tendency to capsize when flooded. After the boat was upside-down, the flotation material provided sufficient buoyancy to keep the boat afloat and stable with the occupants holding to the sides.

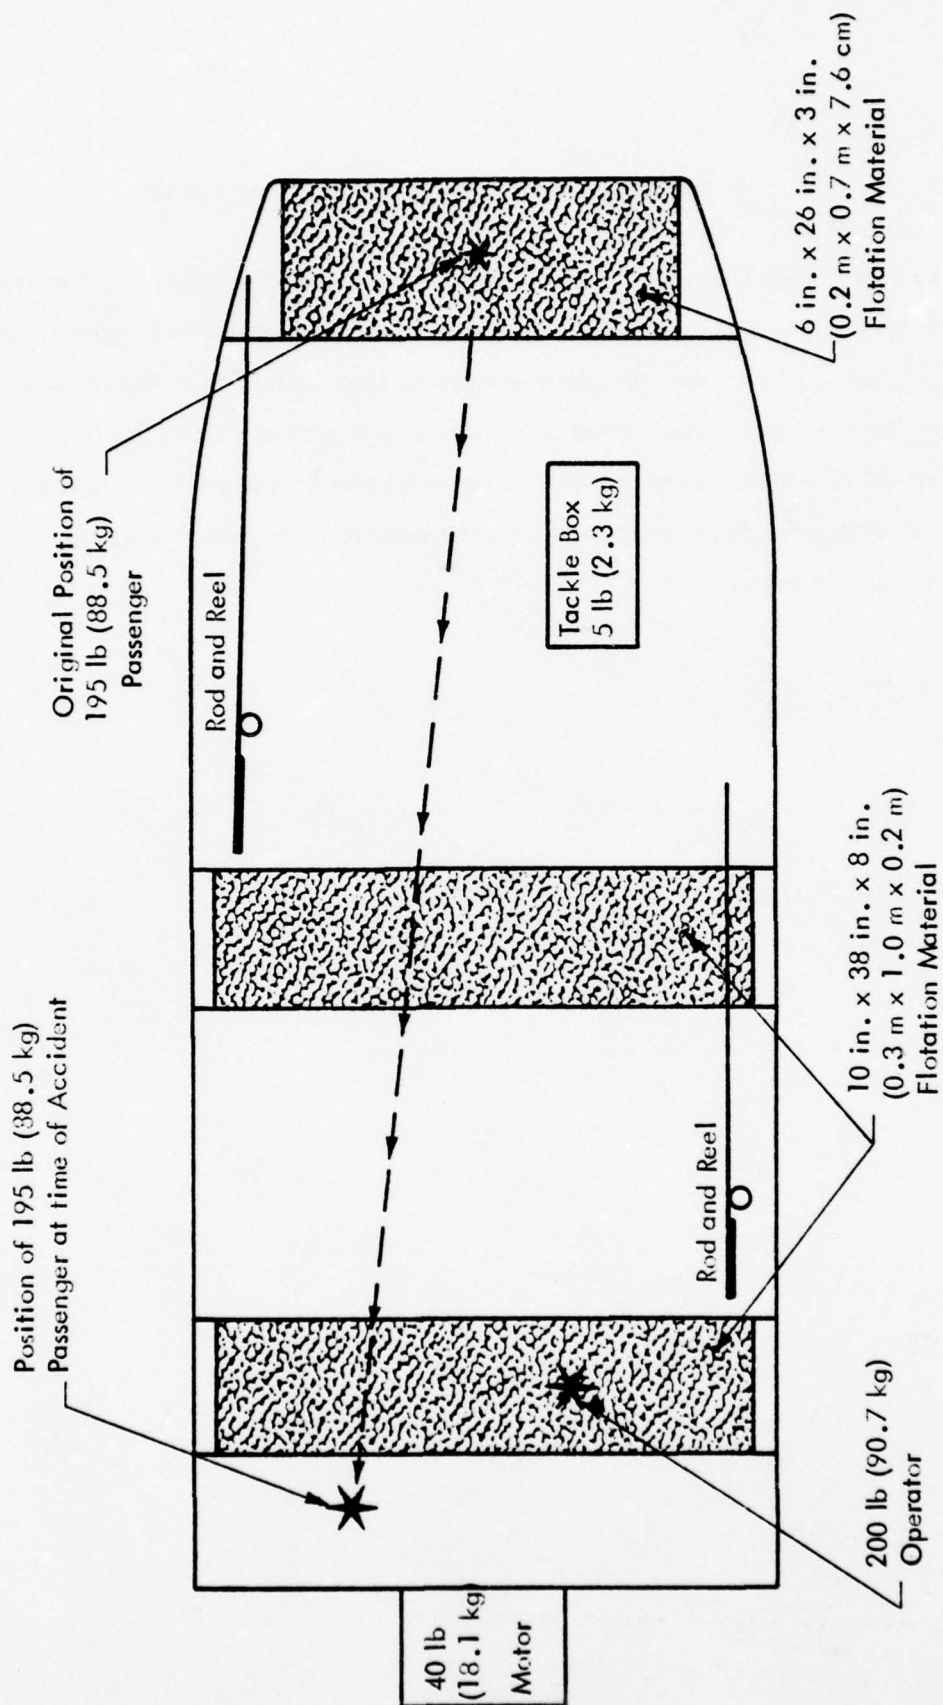
FIGURE 1. LOAD DISTRIBUTION AT TIME OF ACCIDENT

According to the estimated weight in the boat at the time of the accident, the boat was loaded to near the maximum weight capacity. When the passenger moved to the stern, the weight of the two occupants reduced the transom freeboard to zero, allowing water to flow freely over the transom into the boat. The center of gravity of the occupants was much higher than the flotation material, which caused the boat to have a natural tendency to capsize when flooded. The location of the flotation material caused the boat to float in a stable, near level attitude once it was upside-down.

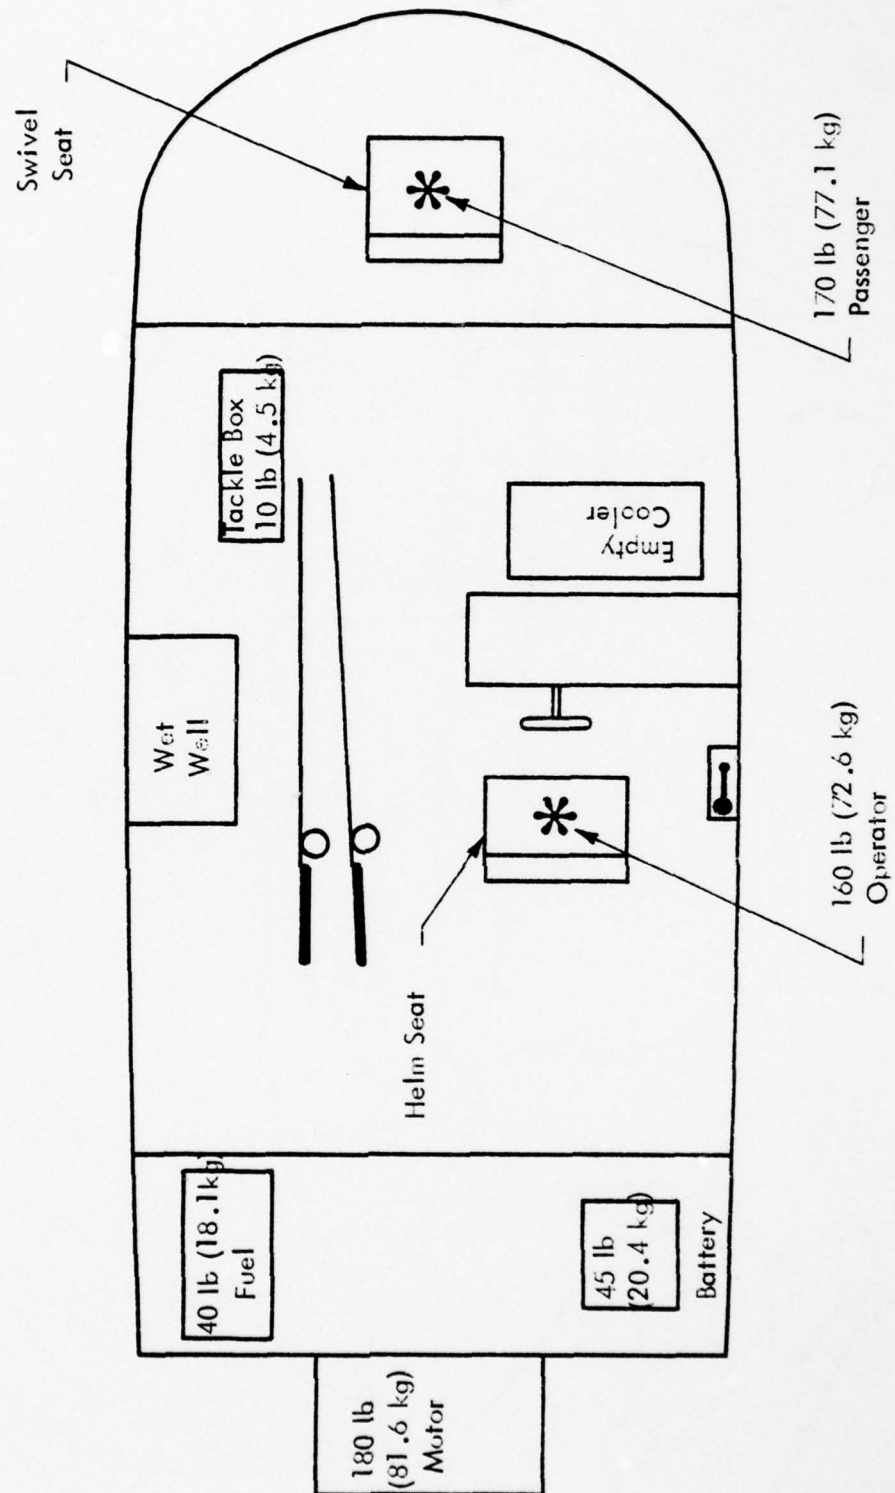
FIGURE 1. LOAD DISTRIBUTION AT TIME OF ACCIDENT

According to the estimated weight in the boat at the time of the accident, the boat was not overloaded. When the motor skeg started dragging on the bottom, it is assumed that the outgoing tide caused the boat to pivot about the skeg until the bow was into the wind and waves. The open design of the boat allowed any water coming over the bow to go directly into the passenger compartment. Partial swamping of the boat over the bow caused the free-board to be reduced significantly. Wave action most likely caused the boat to turn broadside to the waves. Waves over the side completely swamped the boat and, because all the flotation material was installed below deck level, the boat had a natural tendency to capsize when flooded. The motor weight caused the boat to float bow high after capsizing.

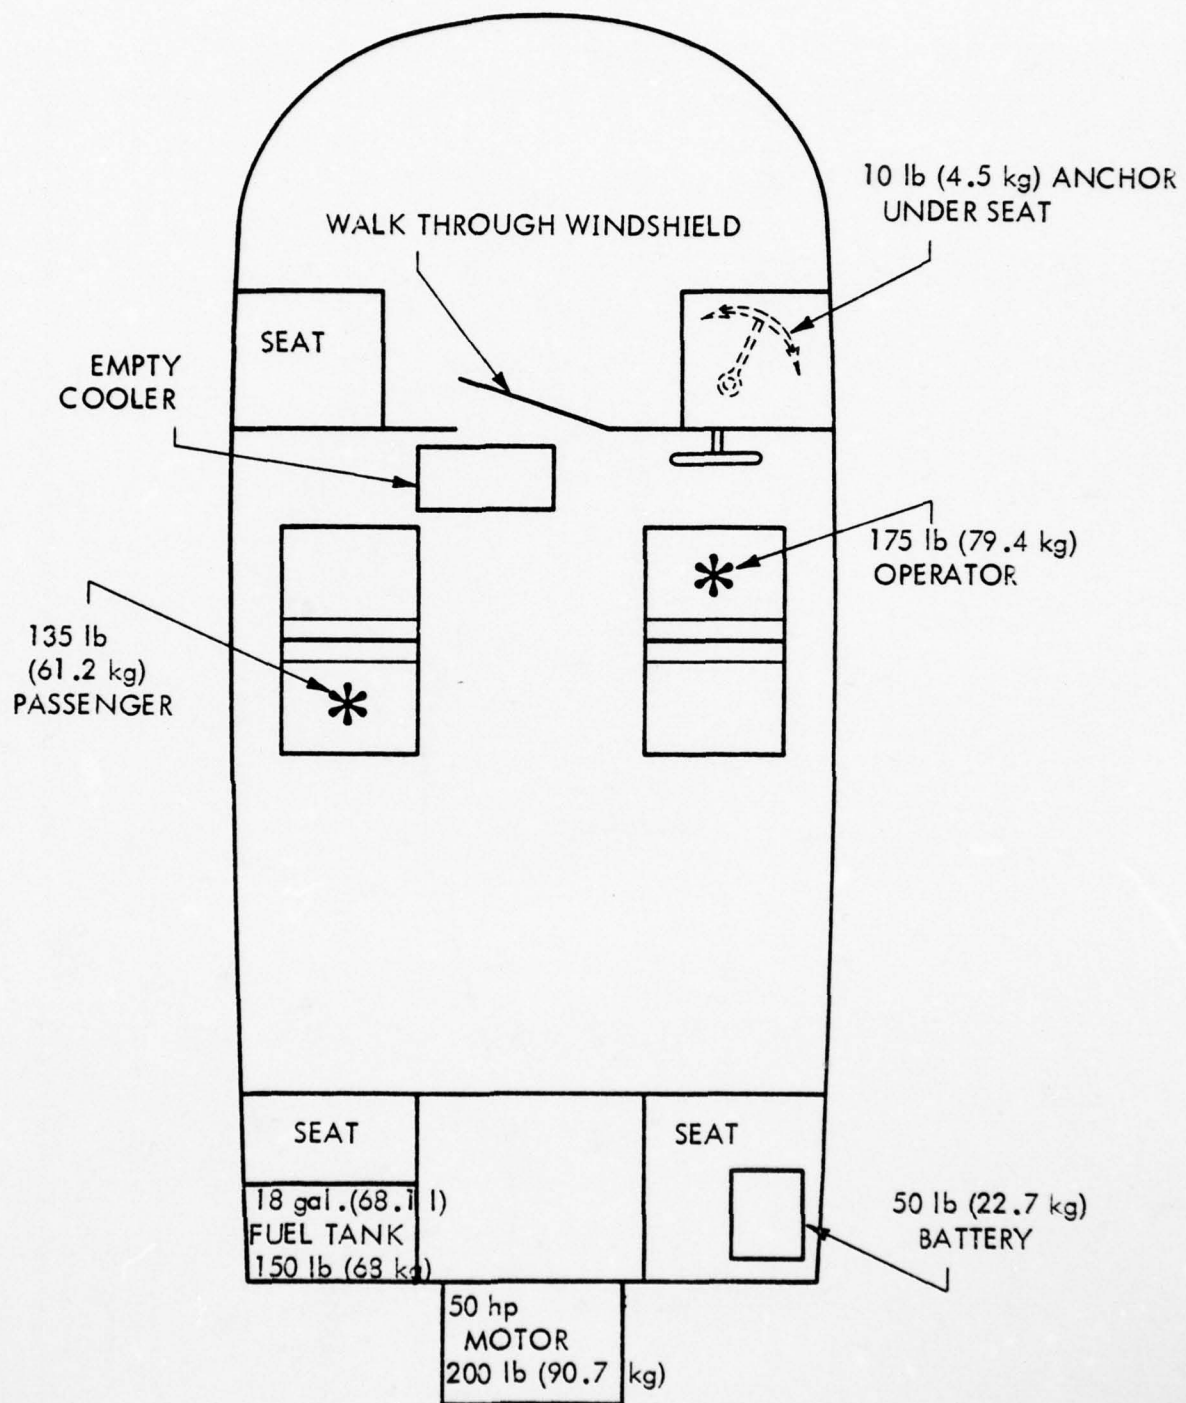
FIGURE 2. LOADING DISTRIBUTION AT TIME OF ACCIDENT

A large wave broke over the bow of an open bow boat. This wave filled the boat with a considerable amount of water and caused the engine to stall. The two occupants moved to the port side of the boat to get PFDs out from the seat where they were stored. Their combined weight plus the free surface effect of the water in the boat caused a heeling moment of sufficient magnitude to capsize the boat. The occupants jumped from the boat as it capsized and assumed an inverted, level attitude.

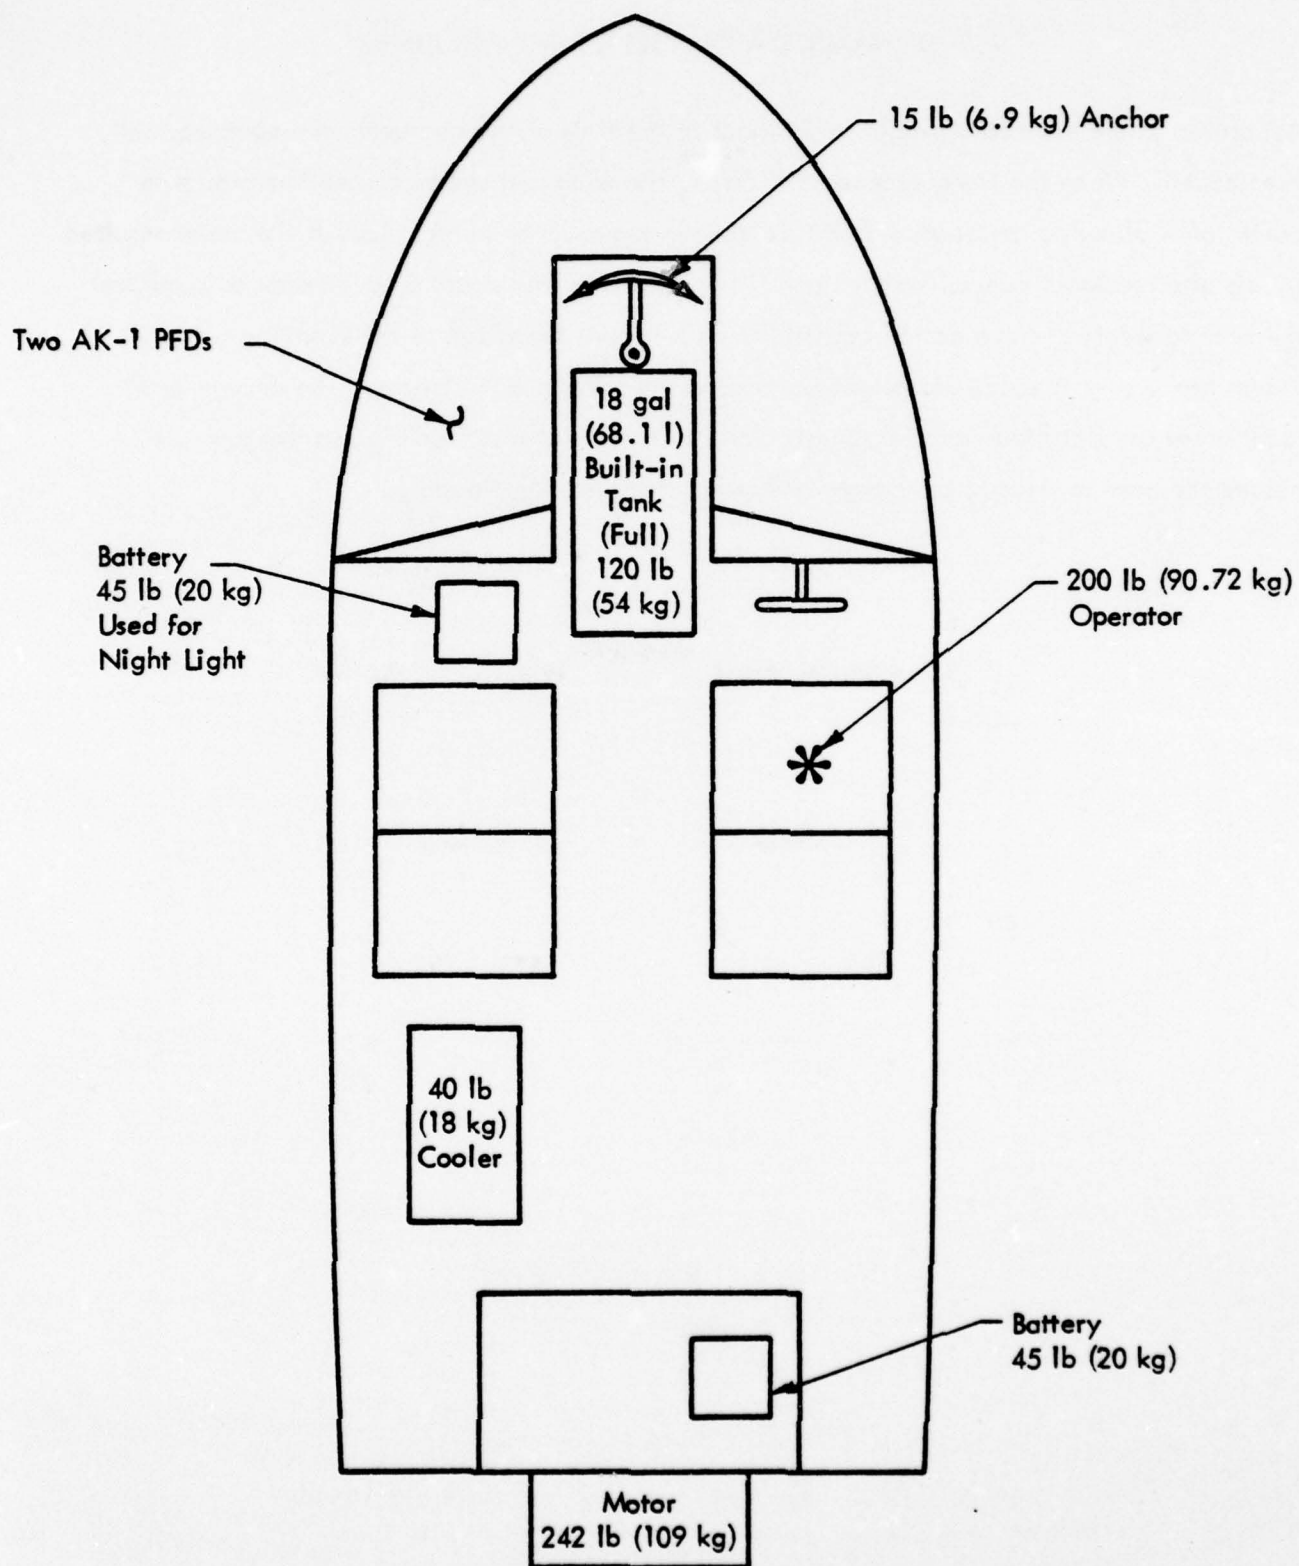
FIGURE 1. LOAD DISTRIBUTION AT TIME OF ACCIDENT

According to the estimated weight in the boat at the time of the accident, the boat was not overloaded. When the storm reached full force, the wind and waves caused the anchor to break loose allowing the boat to drift into deeper and rougher water. Loss of the motor resulted in loss of directional control which made it impossible for the operator to attempt to maneuver the boat to safety. Wave action caused the boat to turn broadside to the breaking waves. Waves broke over the side completely swamping the boat in a short time. The amount and location of the flotation material, particularly the material installed high in the gunwale, caused the boat to float in an upright and level attitude after flooding.

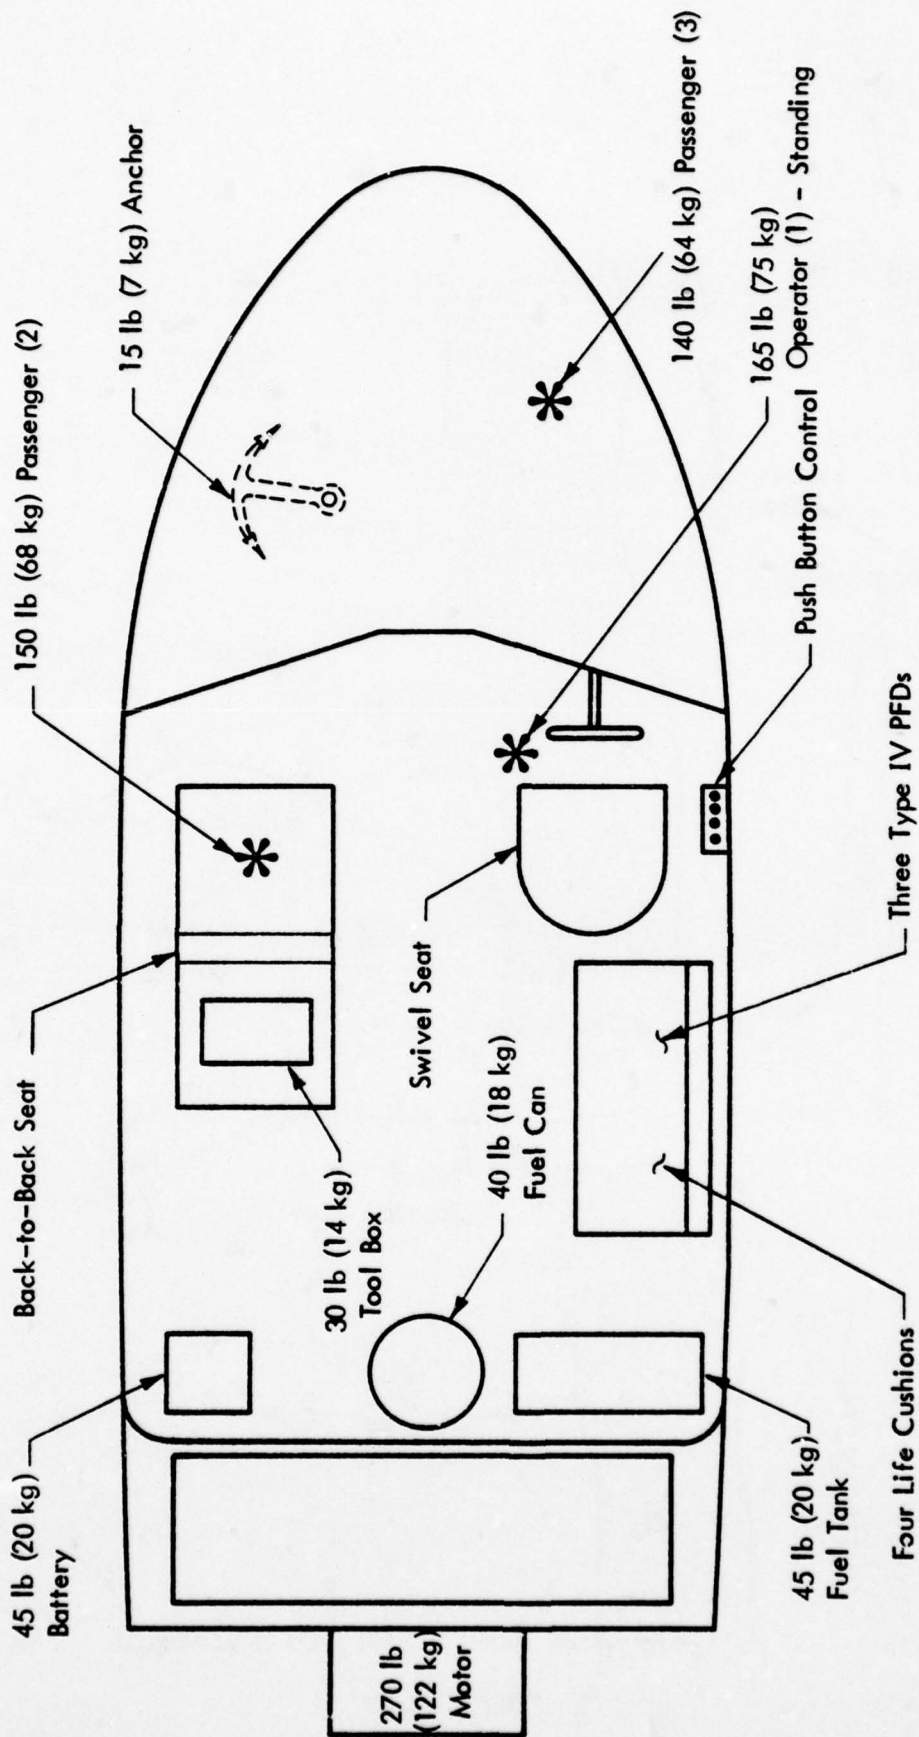
FIGURE 1. LOAD DISTRIBUTION AT TIME OF ACCIDENT

The following is presented based on the narrative and knowledge of the boat characteristics. According to the estimated weight in the boat at the time of the accident, the boat was not overloaded. However, considering the water weight in the stern, the safe maximum weight capacity was most likely exceeded. The water weight in the aft section reduced the transom freeboard significantly and caused the boat to run in a very stern low attitude. When the boat abruptly stopped, the water in the aft section caused the boat to continue to assume a stern low attitude. The transom freeboard was reduced to the point that the stern wake broke over the transom reducing the freeboard to zero. Water freely flowed over the transom completely swamping the aft half of the boat. Flotation material in the inner hull caused the boat to have a natural tendency to roll when flooded. The location of the flotation material made the boat float essentially level and stable in an upside-down attitude.

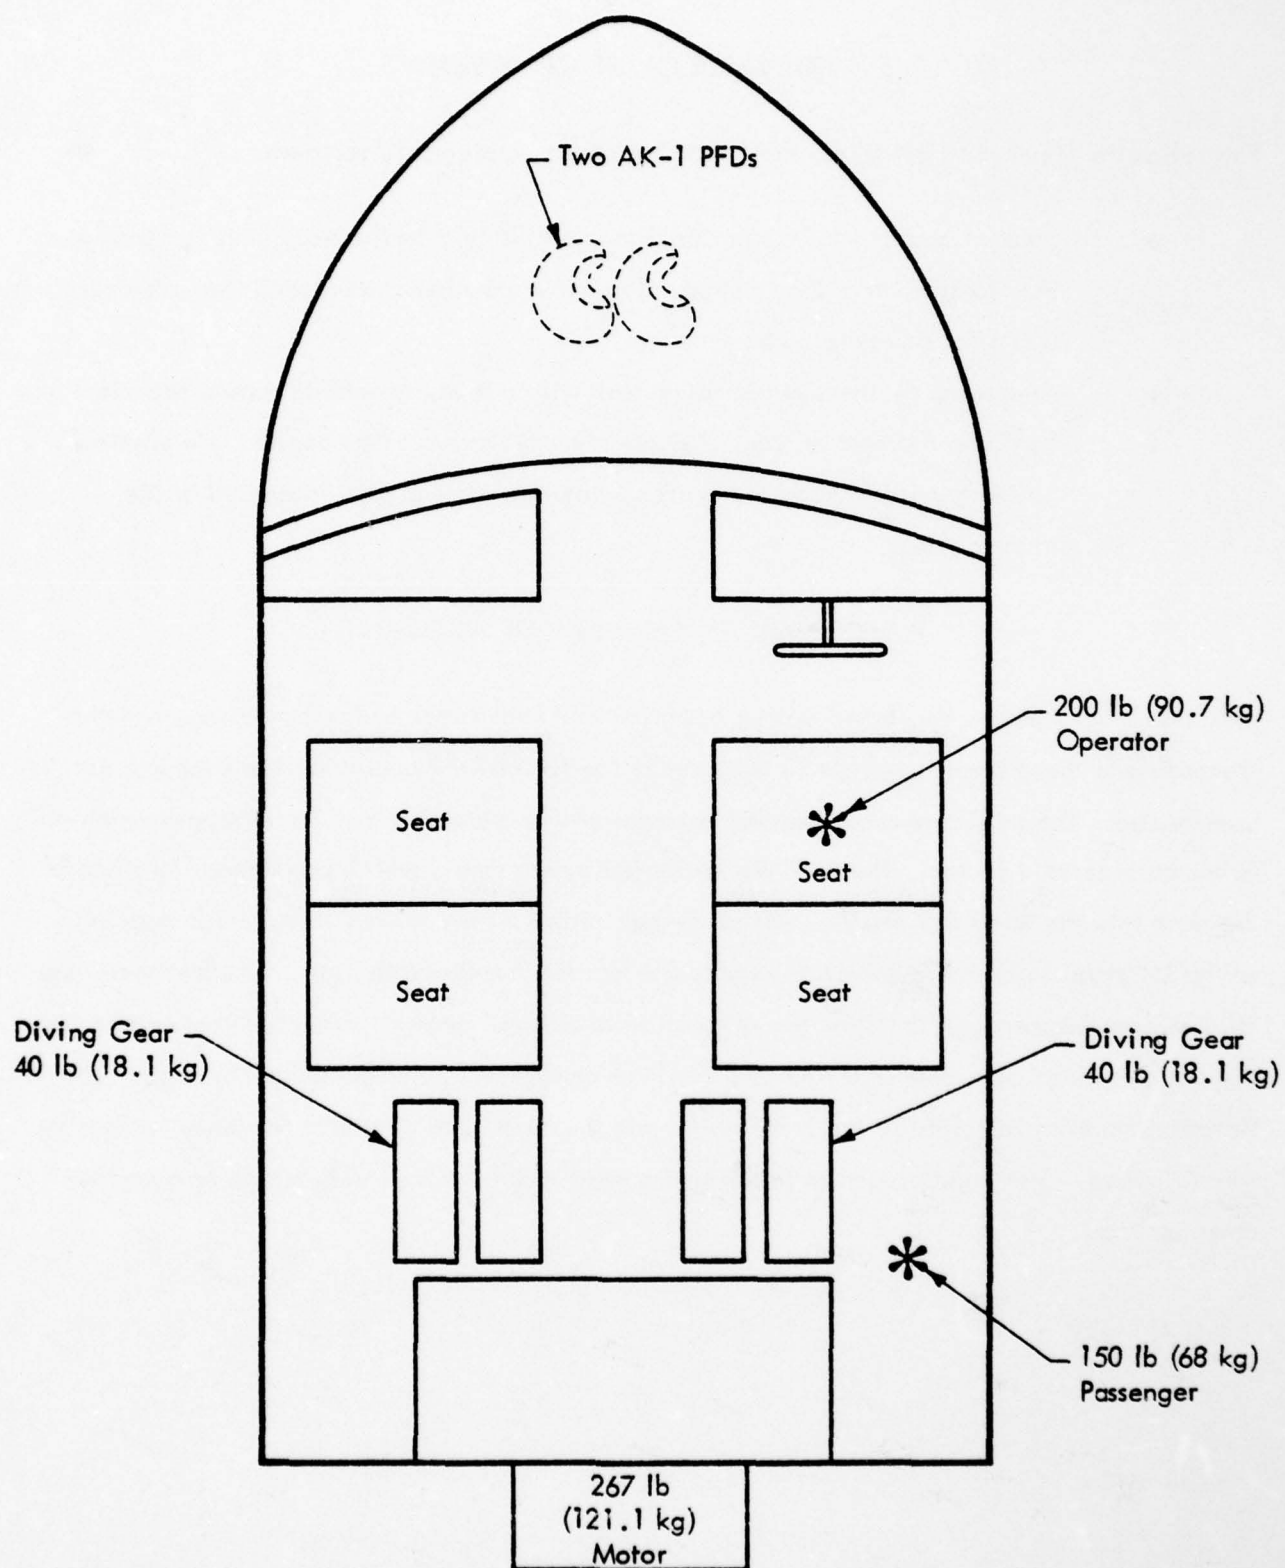
FIGURE 1. LOAD DISTRIBUTION AT TIME OF ACCIDENT

The following is presented, based on the narrative and knowledge of the boat characteristics. According to the estimated weight in the boat at the time of the accident, the boat was not overloaded. The maximum recommended horsepower was exceeded by five horsepower, which is not considered a factor. The boat was anchored by the stern, which positioned the stern of the boat into the wind and waves. The passenger pulled on the anchor line, which applied sufficient pressure on the gunwale to reduce the transom freeboard to zero. The freeboard was held at zero long enough to allow the aft section to fill with water. Free-flowing water over the transom aided by waves breaking into the boat completely swamped the aft section. The flotation material installed in the inner hull made the boat have a natural tendency to capsize when flooded. The location of the flotation material made the boat very stable in a upside-down attitude.

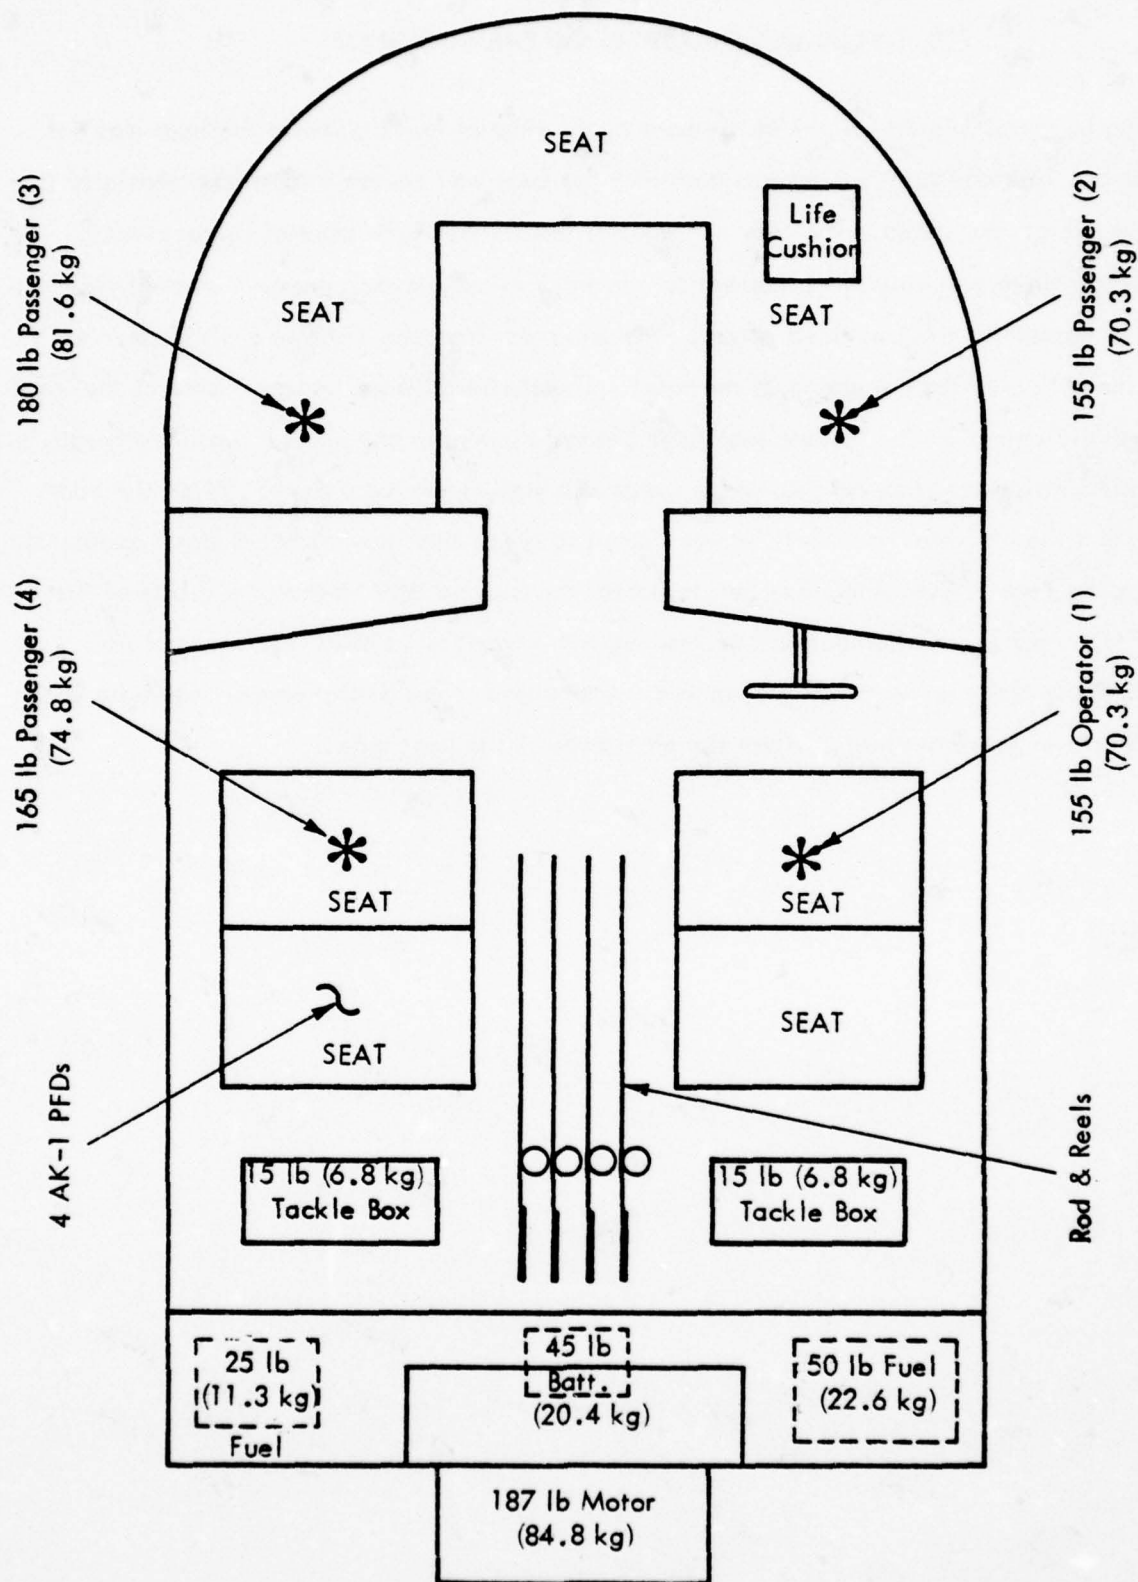
FIGURE 1. LOAD DISTRIBUTION AT TIME OF ACCIDENT

According to the estimated weight in the boat at the time of the accident, the boat was not overloaded. The load distribution was such that the boat was probably running essentially in a level attitude at idle speed. The tide was -0.3 ft (-0.09 m) at the time of the accident, consequently there was very little current or current induced waves. Rough waters in the inlet were caused by wind induced waves. The wind was from the southwest which created a sharp sheer line across the mouth of the inlet. The sheltered water on the inside of the inlet was relatively calm, while the exposed water beyond the mouth of the inlet was very rough. The transition distance from calm to rough water was most likely very short. When the boat went beyond the mouth of the inlet, waves started to break over the starboard stern completely swamping the boat. Wind and wave action causes the boat to drift to the ocean side of the north jetty. Apparently the boat had an insufficient amount or no flotation material installed because the boat eventually completely submerged. The boat probably floated due to entrapped air in the inner hull. When the air escaped, the boat sank.

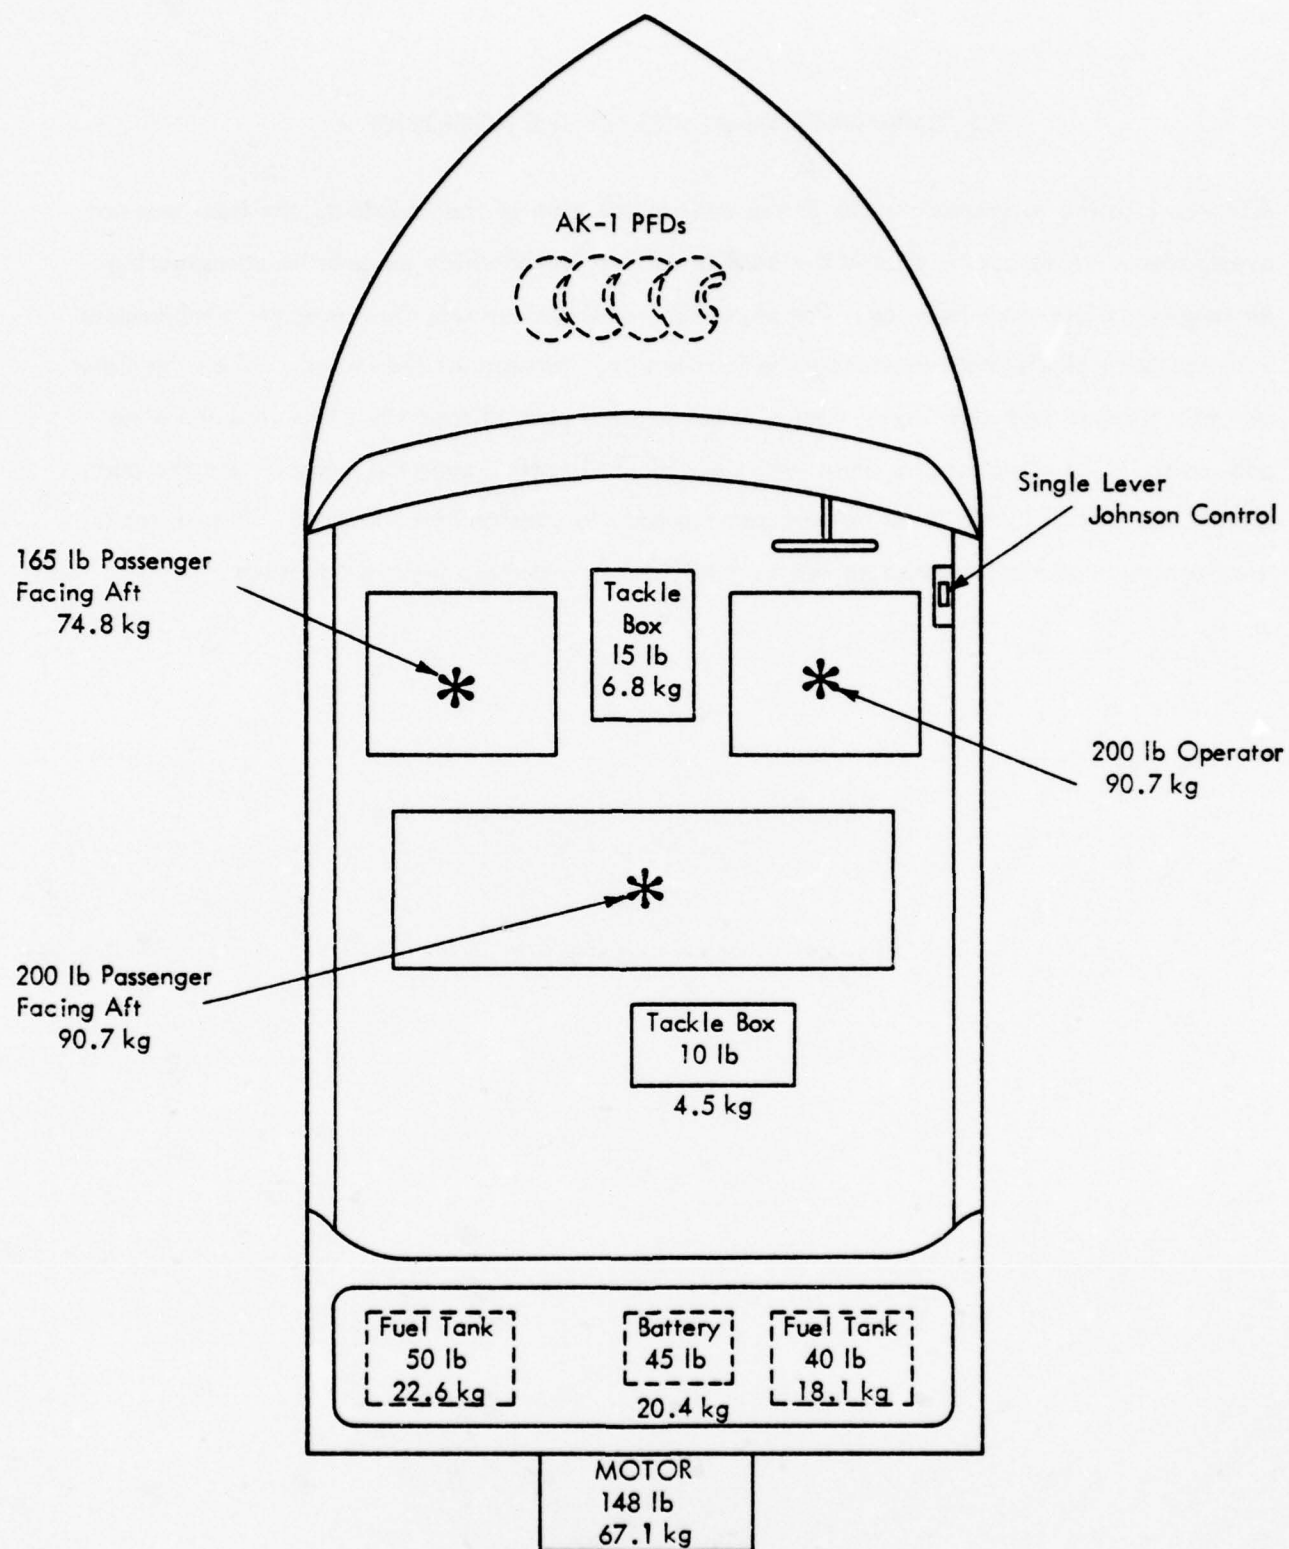
FIGURE 1. LOAD DISTRIBUTION AT TIME OF ACCIDENT

According to the estimated weight in the boat at the time of the accident, the boat was not overloaded. Wave action caused the boat to roll violently which caused the unsuspecting passengers to lose their balance. Passenger (2) was thrown across the passenger compartment with the back of his chair impacting the ignition key, turning off the motor. When the motor abruptly stopped and directional control was lost, the boat drifted stern first into the wind and waves. The wave heights were sufficient to easily break over the transom into the boat. Flotation material in the inner hull caused the boat to capsize when flooded. Placement of the flotation material also caused the boat to float in a stable, inverted attitude.

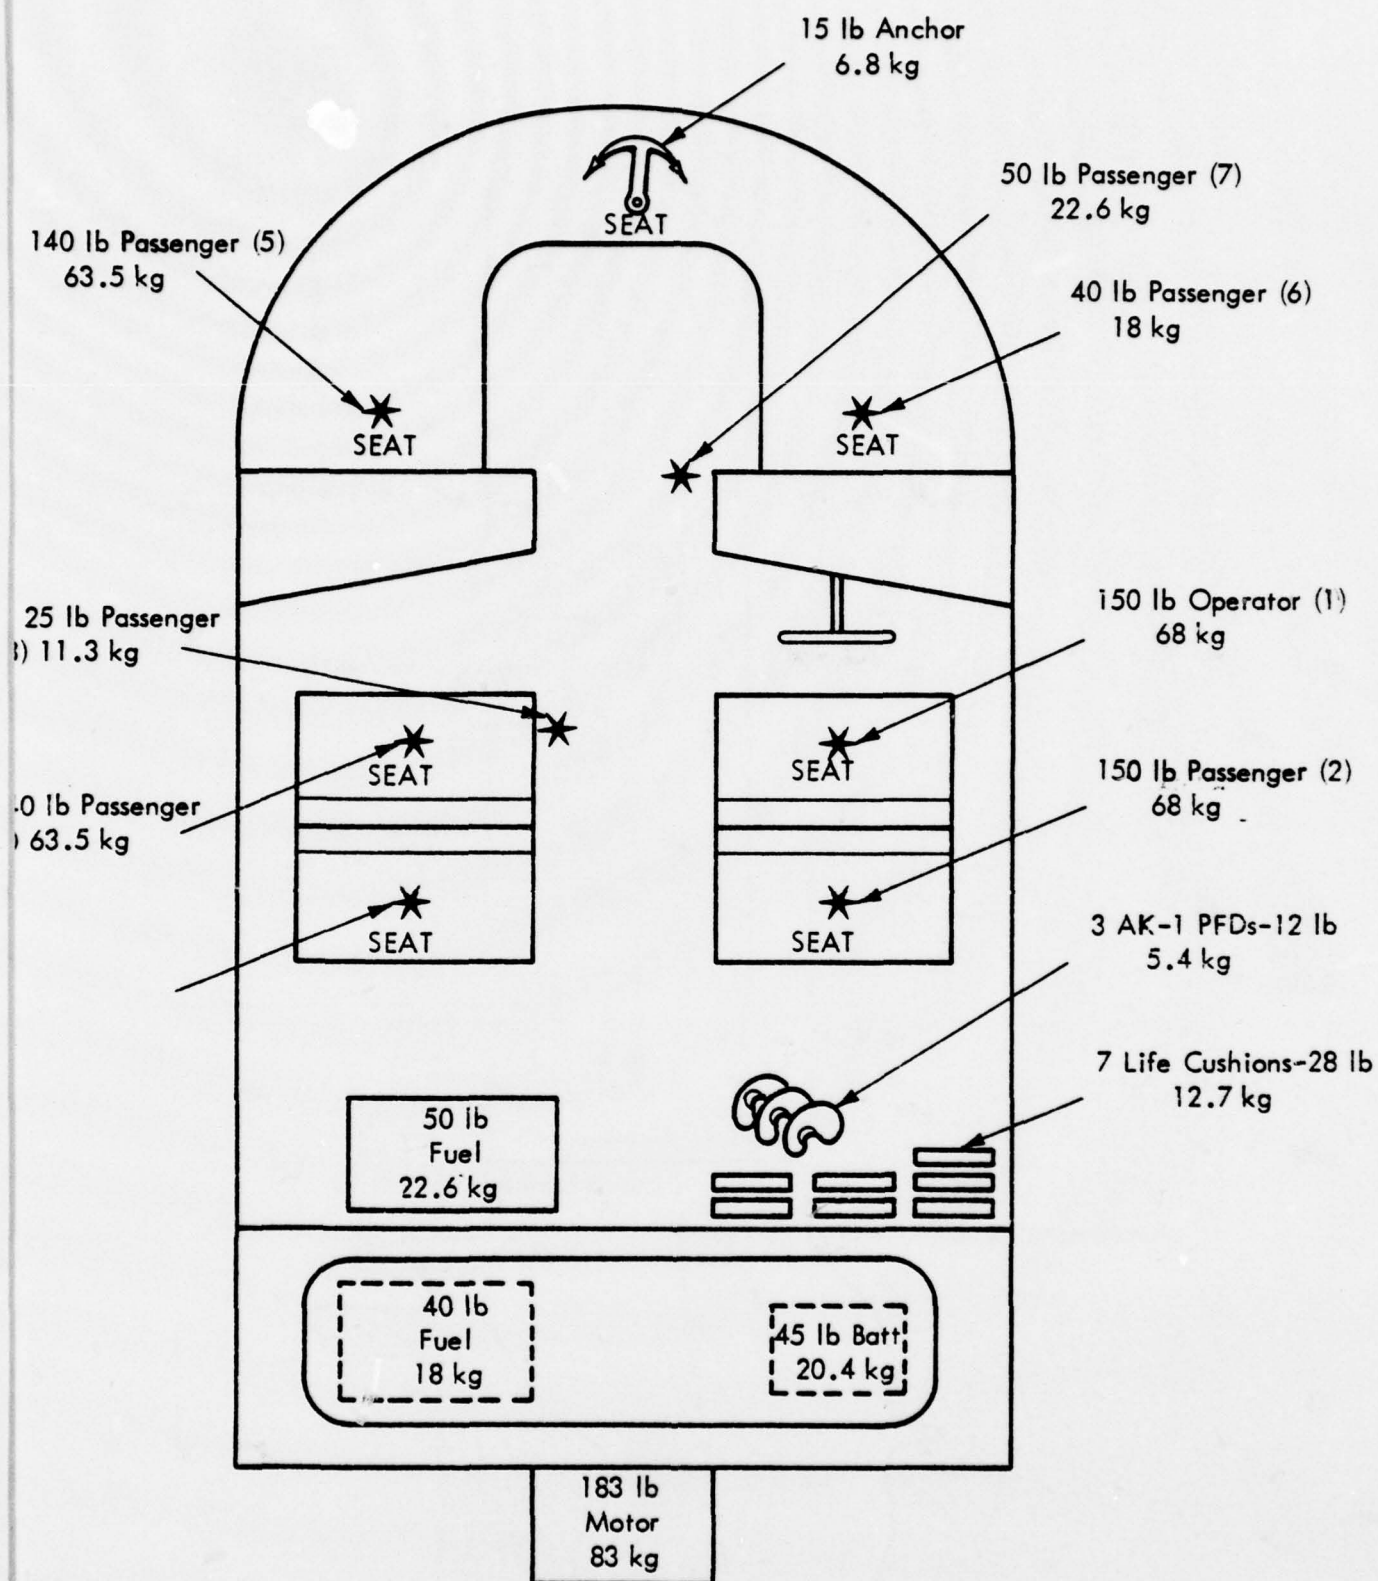
FIGURE 1. LOAD DISTRIBUTION AT TIME OF ACCIDENT

The boat rode over the crest of the wave and headed bow-first into the trough. As the boat started down the wave, any water in the inner hull would flow forward, increasing the weight in the bow. When the bow reached the trough, people and water weight in the bow and forward momentum of the boat caused the bow to slice into the next wave - flooding the forward passenger compartment. The flooded bow section caused the bow freeboard to be reduced to the point that succeeding waves broke over the bow completely swamping the boat. The boat probably capsized due to movement of the occupants and entrapped air in the inner hull. When the boat capsized air pockets were most likely formed in the passenger compartment. The boat remained afloat until the roll and pitch action of the boat caused the air pockets to fill with water.
